New frontiers in irrigation efficiency

The prevalence and hidden potential of drip irrigation issues

Prepared by **Ceres Imaging**

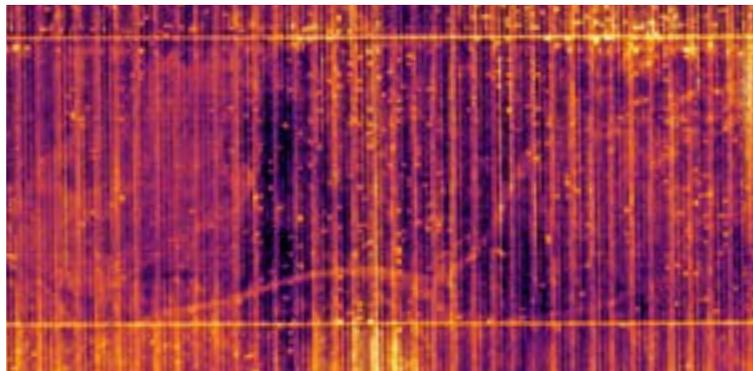
Careful calibration and image correction ensure that irrelevant objects—for example, equipment, ground cover, or soil—don't skew the data. In the resulting imagery, cooler areas appear purple, while warmer areas appear yellow.

High-
resolution
thermal
imagery →

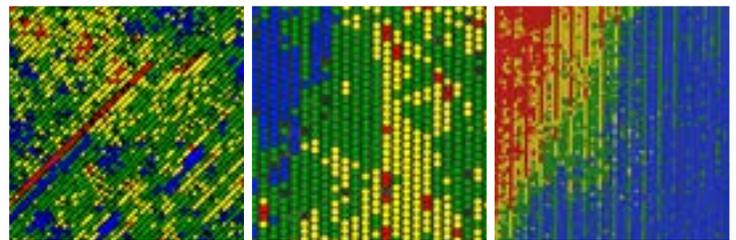
CLOG

LEAK

**PRESSURE
ISSUE**

Not all irrigation issues are detectable in imagery. Conversely, not all issues detectable in imagery are irrigation issues. However, imagery in combination with analytics tools consistently reveals the most common drip irrigation issues, including clogs, leaks, and pressure issues.

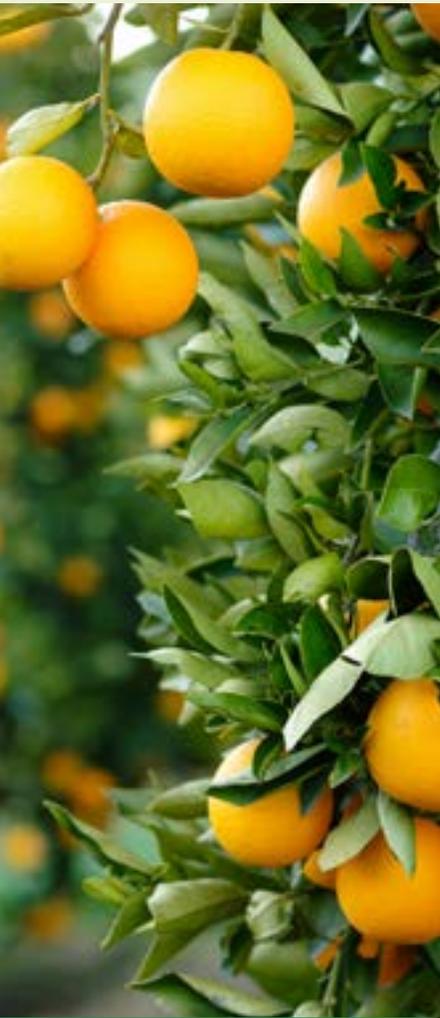
HOW DOES THE IMPACT OF DRIP IRRIGATION ISSUES VARY BY CROP?

Irrigation issues resulting in crop stress per 1,000 unique acres

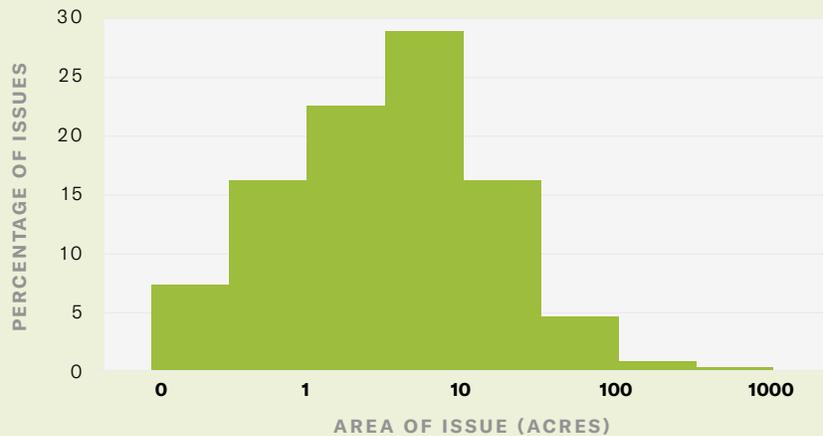
Average issue size

MEAN ISSUE SIZE

9.9 acres

MEDIAN ISSUE SIZE

3.3 acres

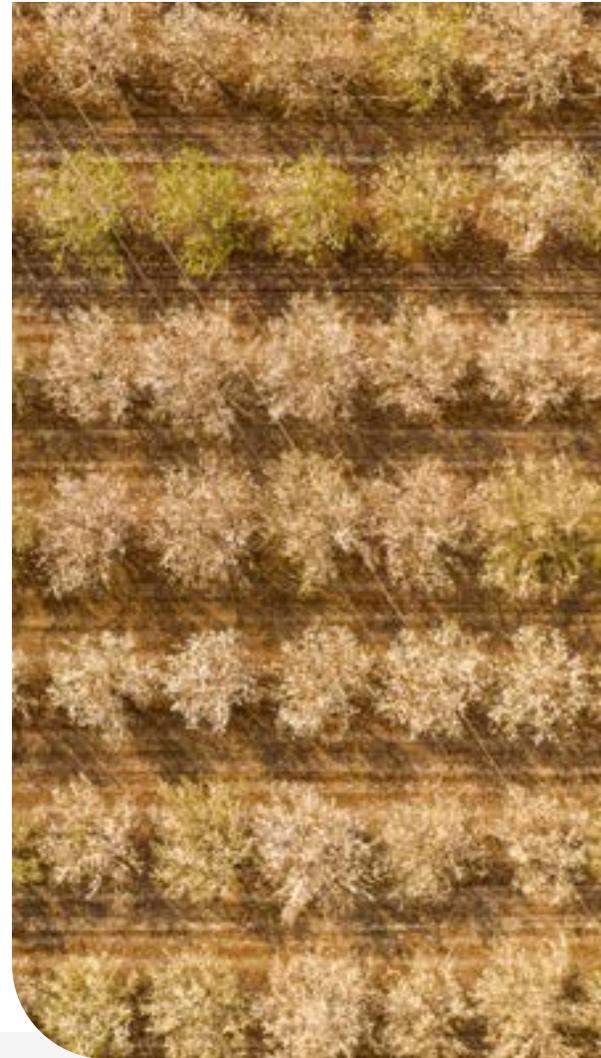
Using this method, we find that the average issue results in 8.8% more stress on the affected area than the unaffected area.

Thermal stress and acute irrigation issues

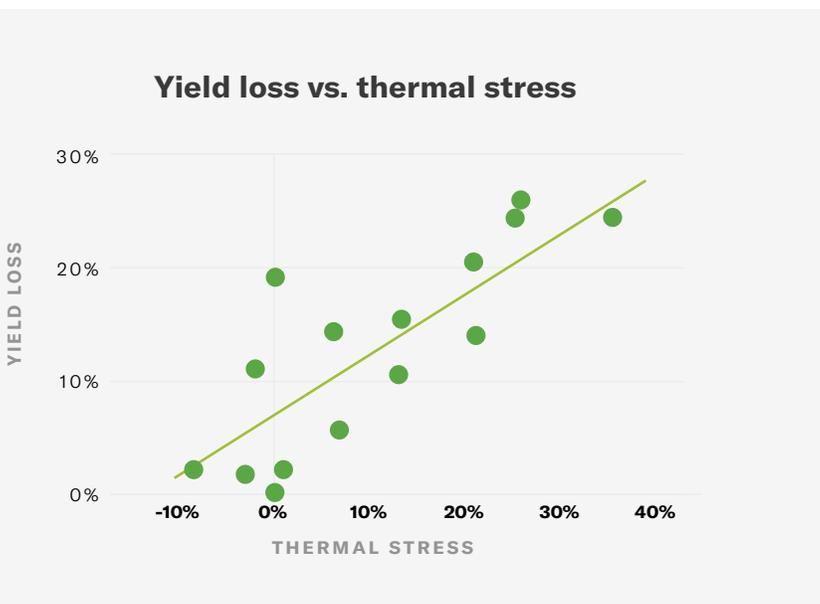
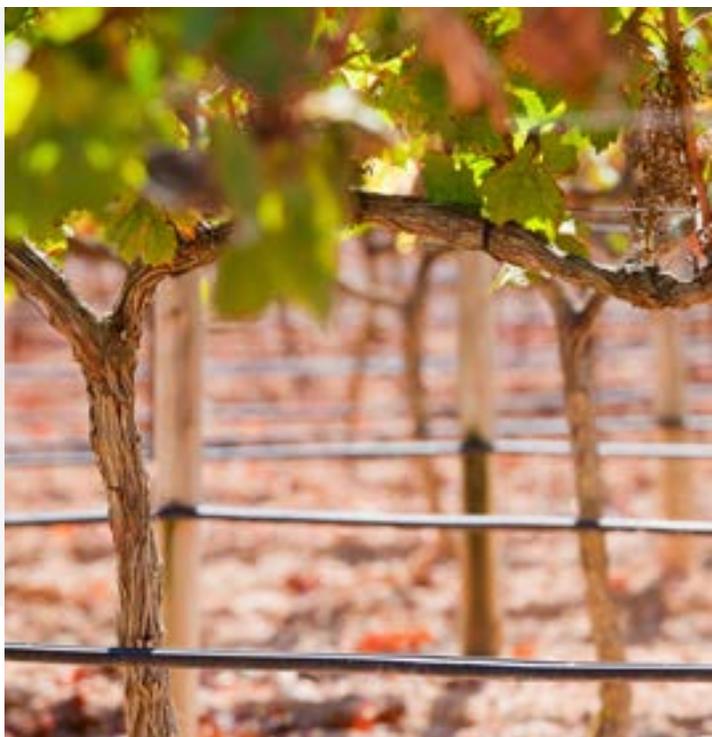
The figure below shows the relationship between thermal stress and yield within 1-acre plots in the experimental almond orchard investigating the relationship between water and yield in almonds.

To estimate the impact on irrigation issues on yield, we therefore consider Ceres Imaging customer data, collected between 2014 and 2020, in combination with findings from a four-year study of almonds in partnership with Blake Sanden at the University of California Cooperative Extension. The results of our work with Sanden and others inform the relationship assumed in this report, that a 10% increase in stress results in a 5.5% decrease in yields.
